Saudi J Anaesth. 2014 Oct-Dec; 8(4): 567–568.

An unexpected error in oxygen humidifier

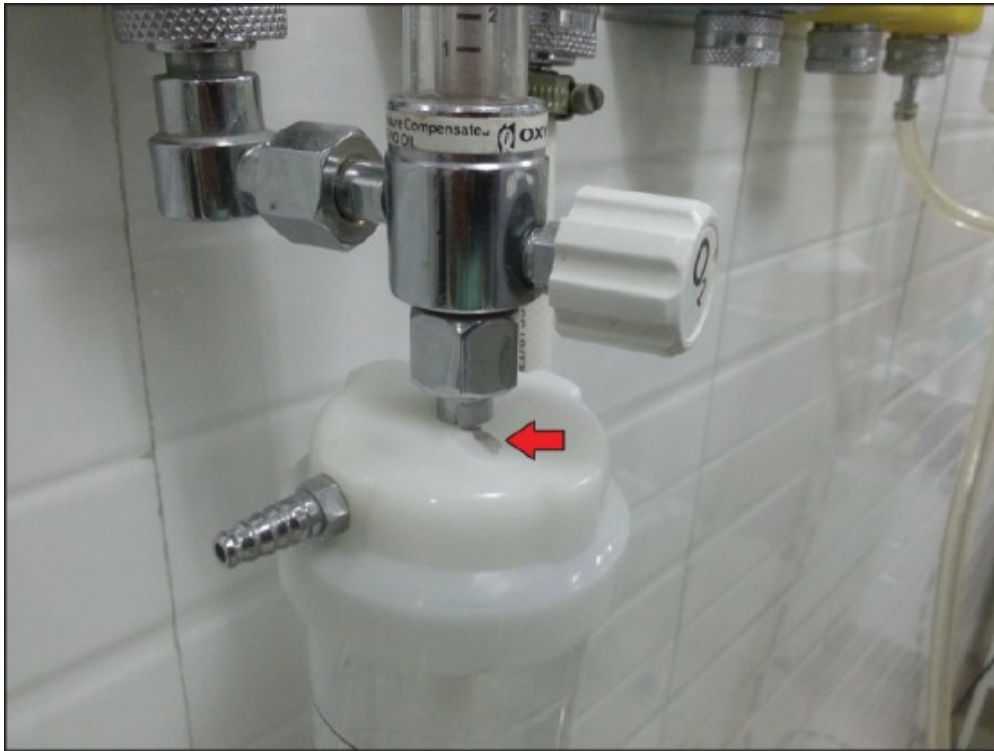
Figure 1

Arrow showing damaged part in the lid

Oxygen is an important and essential gas for all living beings. Many different techniques are used to deliver oxygen to patients either to treat pathological conditions or to supplement during the perioperative period.[1] Equipment malfunction is a problem of particular importance during anesthesia and resuscitation.[2] Such problems hence extend from operation theater to high dependency unit (HDU) if care is not taken. Oxygen can be delivered in dry or humidified form. Advantages of supplementation of humidified oxygen are that, it prevents hypothermia, inflammation of the airway epithelium, bronchospasm, atelectasis and airway obstruction.[3] Humidified oxygen is one of the methods of delivery and commonly used in perioperative area and in HDU. Here, we share our experience of patients in the post-operative area who failed to maintain oxygen saturation which were actually preventable. Two times we observed fall in saturation in our post-operative setup in two patients one who underwent thoracotomy and other cardiac surgery. After extubation patients were conscious, oriented and pattern of breathing was acceptable. After the supplementation of oxygen at 10 L/min through simple mask, there was no improvement in saturation instead we noticed a drop in saturation from 96 (with room air) to 94% in both patients. After thorough inspection of humidifier we could see bubbles in humidifying chamber with bobbin positioned at 10 L marking with the absence of gas at output. On detailed inspection, the lid of distilled water chamber was damaged [Figure 1] in first and the leak was appreciated at the junction of the lid and input port of oxygen into the humidifying chamber [Figure 2] in the second case. The fall in saturation was due to the loss of humidified oxygen through low resistance area, i.e., through a hole in damaged lid in first and at the leaking site in the second scenario. Hence patients were actually not supplemented with humidified oxygen. Visual evidence of bubble formation in humidifying chamber and bobbin position at the set level may confirm entry of oxygen in humidifying chamber but doesn't assure delivery of oxygen to the patient. Hence, it is important to have leak proof and undamaged oxygen humidifier. The key message here is one should not jump into conclusion which may lead to invasive techniques like mechanical ventilation if saturation is not maintained, rather technical or mechanical errors should be identified and rectified. Inadequate experience and insufficient familiarity with equipment does contribute for such failure. High index of suspicion is necessary to identify such errors in the oxygen delivery devices which are most commonly practiced. It is important to have good quality medical devices and should never be a compromise in emergency and HDU.

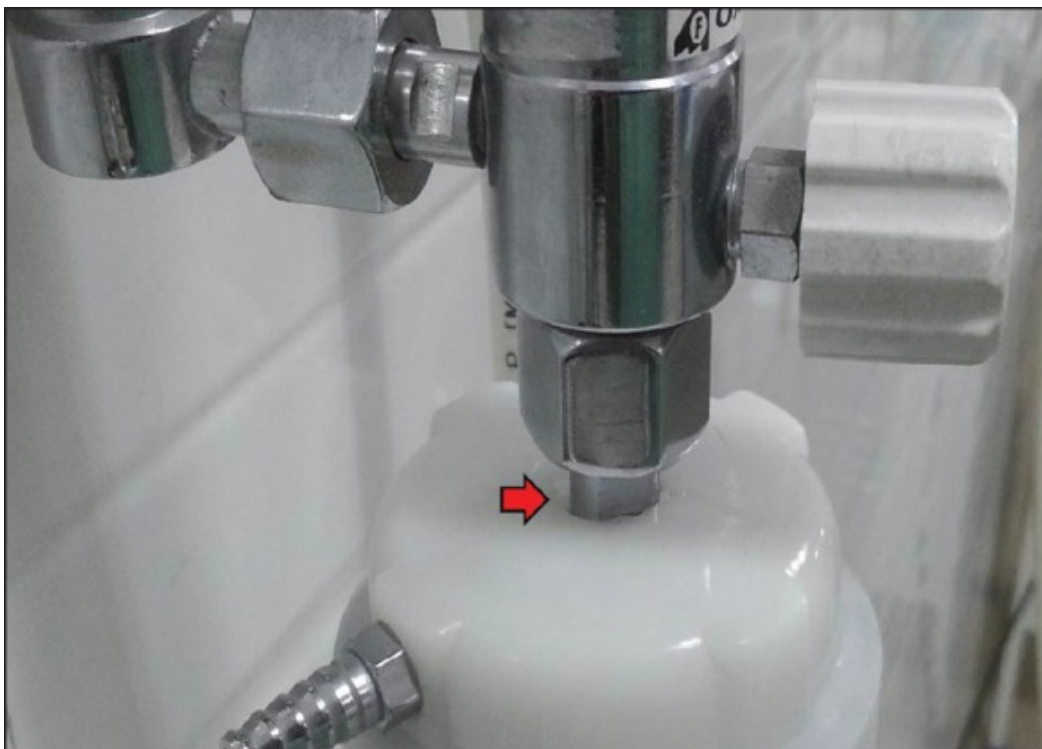
Figure 2

Leak at the junction
